RISK MANAGEMENT OF A FORMER SALT STORAGE YARD

Robert S. Nichols, B.Sc., P.Eng.[†] and Trent Parks, Ph.D., P.Chem.^{††}

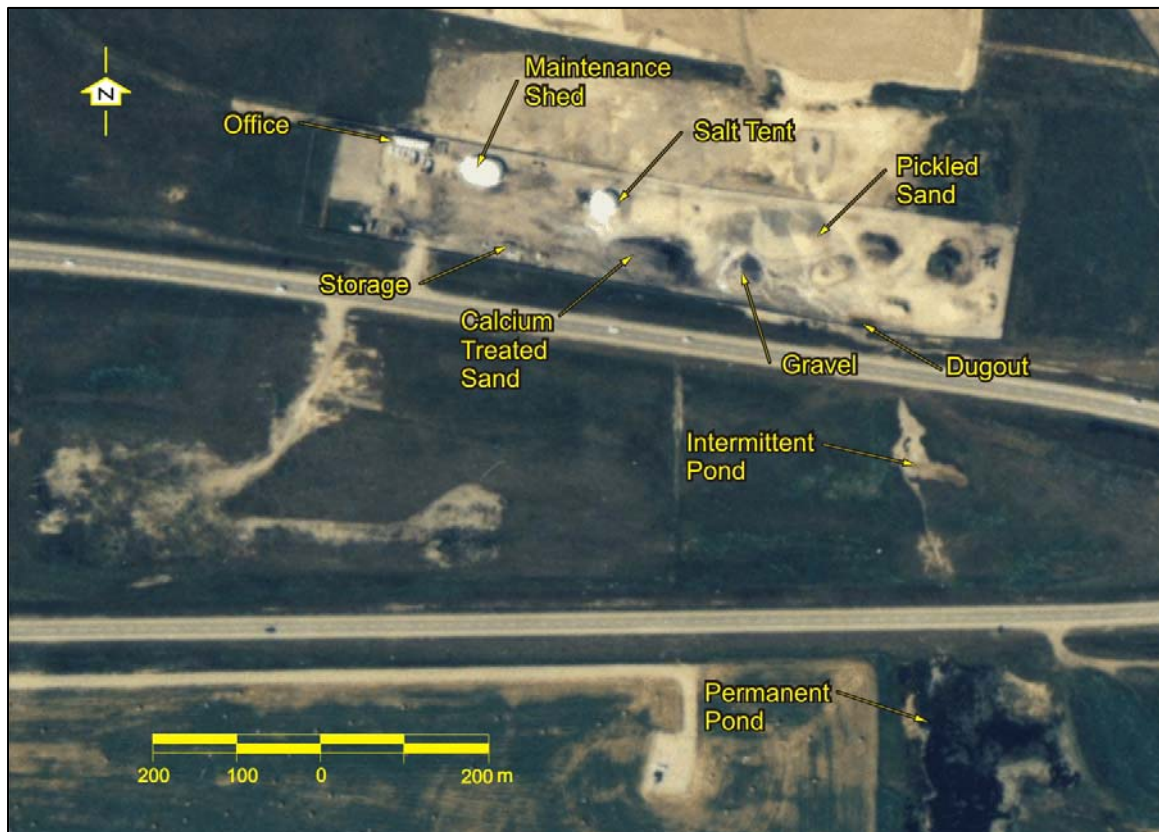
Figure 1: 1998 aerial photograph of the site showing the site facilities as well as the westbound (top) and eastbound (bottom) lanes of Highway 22X, an intermittent pond within the median and a permanent pond south of the highway.
