USE OF NATIVE SPECIES IN THE RESTORATION OF A TRAIN DERAILMENT SITE

David Flynn¹, David Charlton¹, Coby Lamarche¹, Chris Zoladeski¹

¹ Stantec Consulting Ltd.

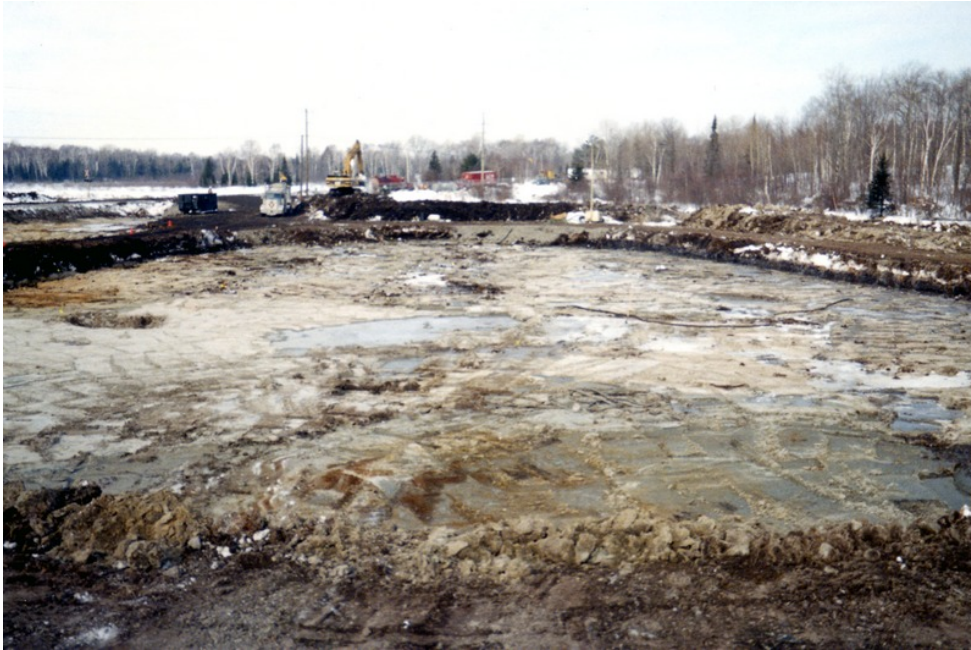
Photograph 1: View of Site at Completion of Initial Remediation Activities

The excavation was not backfilled, and following the spring freshet, the Site was inundated with water, forming an open body of water.

Photograph 1 shows a panoramic view of the site at the completion of the initial remediation program.

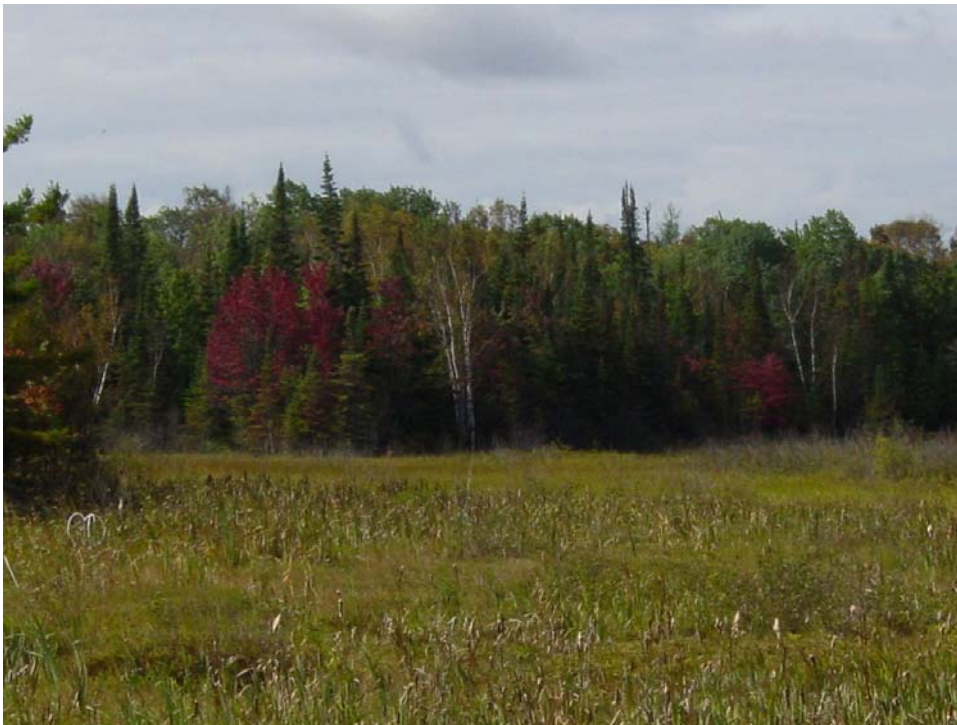
Photograph 2: View of Typical Marsh Vegetation on Opposite Side of the Road

Since the derailment occurred when there was a significant snow cover on the wetland, it was not possible to definitively ascertain pre-remediation conditions. However, the affected wetland area was part of a larger wetland that was dissected by a road, and it is likely that the Site was similar to the unaffected wetland on the opposite side of the road. The wetland on the opposite side of the road contained large mats of emergent vegetation dissected by narrow water channels.

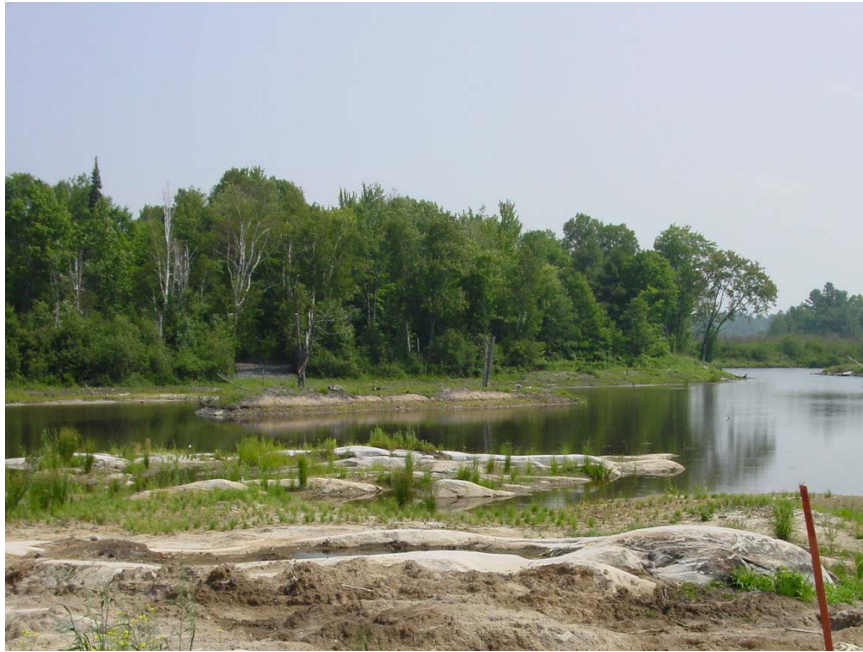
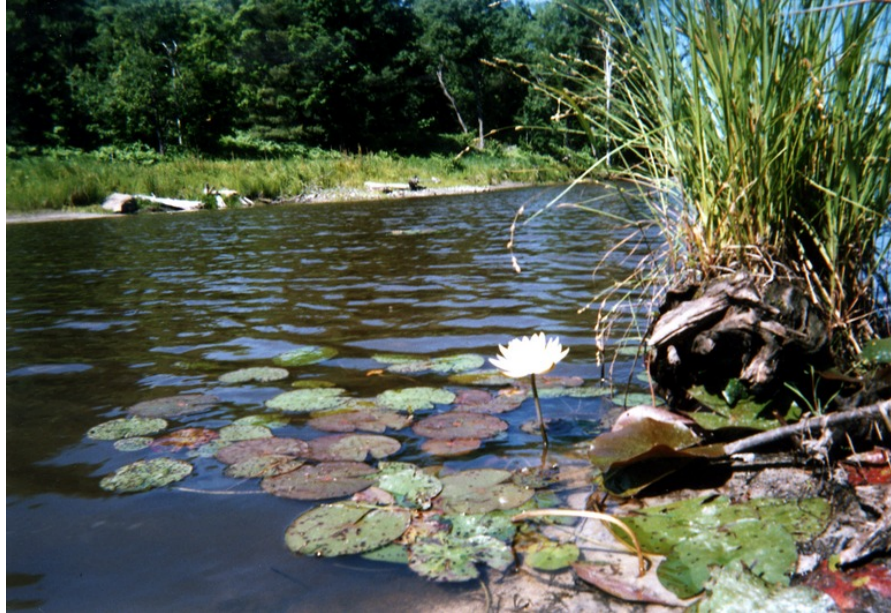
Photograph 3: View of the Restored Wetland from Railway Tracks

Photograph 4: View of Marsh Vegetation

Monitoring in 2005 indicated that, compared with the situation in 2004, there had been a general increase in plant and vegetation cover throughout the experiment wetland restoration site. This progress in re-vegetation can be attributed, to a large degree, to the drop in wetland water levels in 2005. This has resulted in wide areas being exposed and subsequently invaded by numerous wetland species and some upland plants. For example, bur-reed, cattail, blue-joint grass and needle spike-rush spread out over the newly-available ground, as well as species typically associated with mudflats, such as false pimpernel and marsh purslane. Photographs 3 and 4 show typical views of the wetland in 2005.
