PREDICTIVE MODELLING AND MONITORING NATURAL ATTENUATION TO SAVE REMEDIAL COSTS

A.Aziz Shaikh, Brian Tsang, Greg Sutor and Thomas Dance

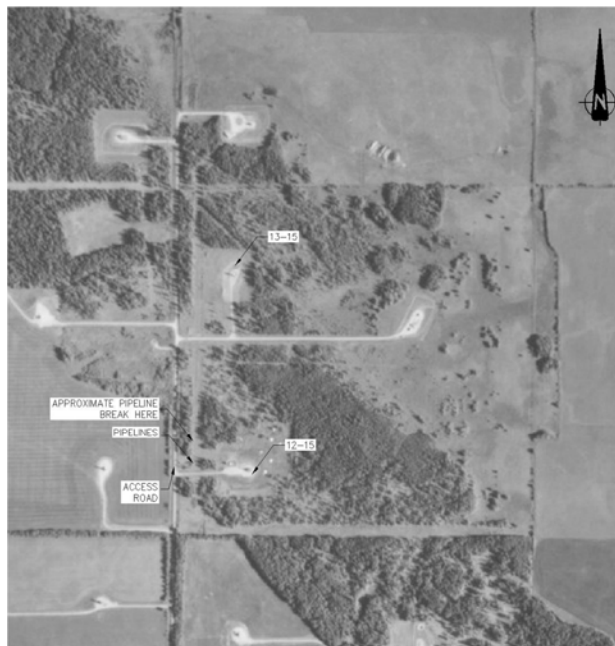
Figure 1: Site Plan

In the fall of 2002, an instrument technician identified a poor test result for a pipeline running north-south between two well sites 12-15 and 13-15 (Figure 1). The well sites are located in central Alberta, Canada. On visiting the site, the technician encountered standing oil and water. The pipeline failure occurred in peaty soils used as summer pasture. It is not known for how long the pipeline leaked. The cause of the break was understood to be badly corroded pipe. The line was shut in and produced fluids were routed elsewhere.

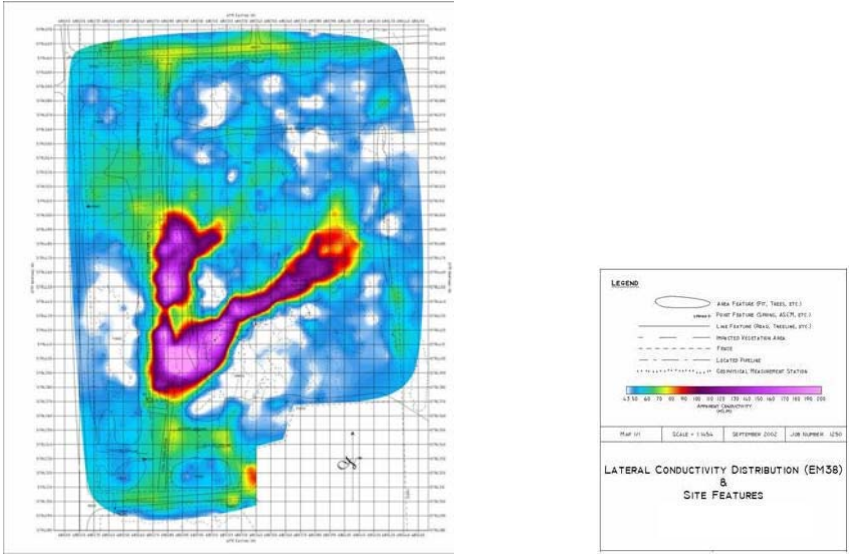
Figure 2: 2002 EM38 Survey – Adjusted Scales

Adjusting the EM survey in 2002 and in 2003 to similar terrain conductivity scales (Figure 2 and Figure 3), it was observed that the area of the greater terrain conductivity decreased over a year and the plume had migrated downgradient towards the northeast. The trends in the terrain conductivity changes supported the hypothesis of natural process for the attenuation (dilution) of chloride mass. Therefore, it was decided to proceed with the alternative option of additional site assessment and monitor the natural attenuation (dilution) processes.

2002 EM survey results showed that the area in the vicinity of the pipeline spill was highly impacted with the greatest EC values (Figure 2). During the initial pipeline spill response (September 2002) chloride concentrations of 39,100 mg/kg was detected in a soil sample collected in this area. Due to the shallow depth to the groundwater, this concentration was considered to be present within the saturated zone and; therefore, affected the groundwater quality. 2003 and 2004 EM38 maps showed a plume (red/purple colour) along the northeast pathway, which had migrated from the spill area to the northeast pathway. Fate and transport of this contamination plume was assessed in the model. The model was based on the mass of chloride in a volume of a cell represented dimensionally by a conventional time length (travel distance) and area comprising of a mixing width and depth during a time step. The mass of chloride is being diluted by the processes of infiltration through recharge, horizontal, and vertical groundwater flow (Figure 11). The mass in the cell during one time step will be the sum of the mass entering to the cell though horizontal groundwater flow, infiltration through recharge and upward groundwater flow as represented by transport model matrix (Figure 12).

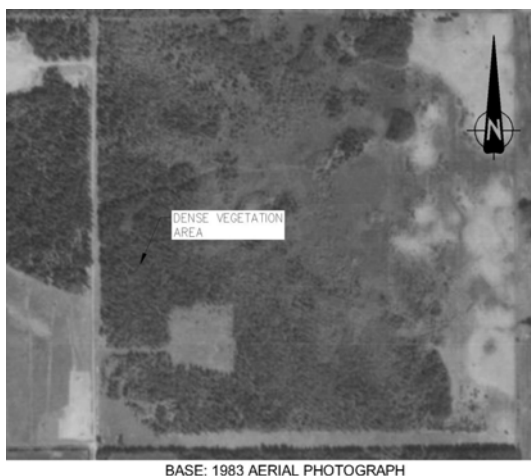
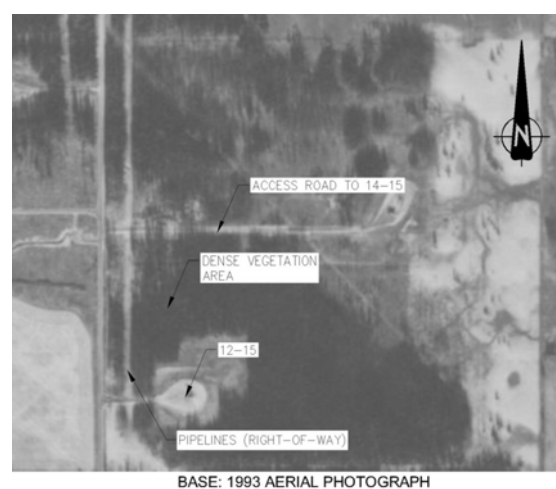
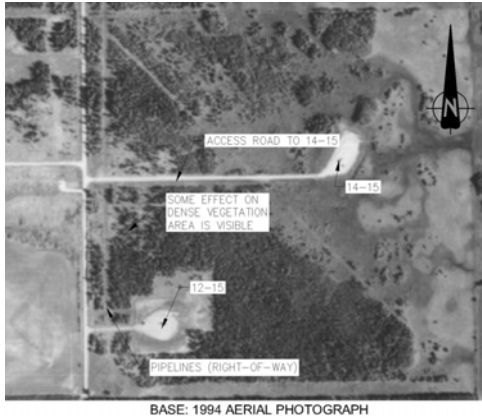
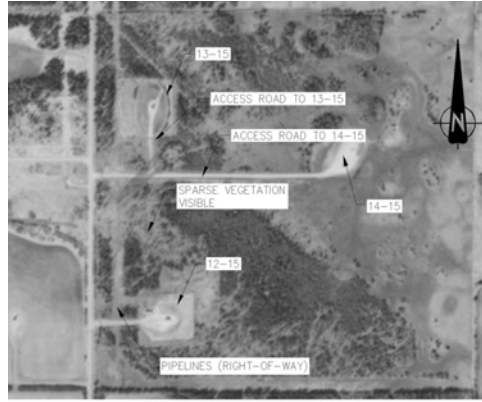
Figure 4 A, B, C, and D show the aerial photographs of the area for the year 1983, 1993, 1994, and 1998, respectively.

The aerial photographs show dense vegetation in the affected area till 1993 and some effect in 1994. In the next available photograph (1998) sparse vegetation in the northeast of the spill area was observed, which suggests the vegetation stress in the northeast of the spill area occurred between 1993 and 1998 prior to the spill. Construction of downgradient roads and well sites may also be observed during that period, which supports the earlier assumption that the numerous construction activities had restricted the flow off of the site, consequently resulting in the rise in the water table

The natural surface drainage was observed from southwest to the northeast towards the affected vegetation area. There were numerous constructions (roads and well sites) within the natural surface drainage path (i.e., upgradient and downgradient of the affected vegetation area), which potentially had restricted the natural flow pattern. The upgradient construction increased the surface runoff to the site and downgradient construction restricted the flow off of the site; consequently resulting in the rise in the water table and ponding of surface water.

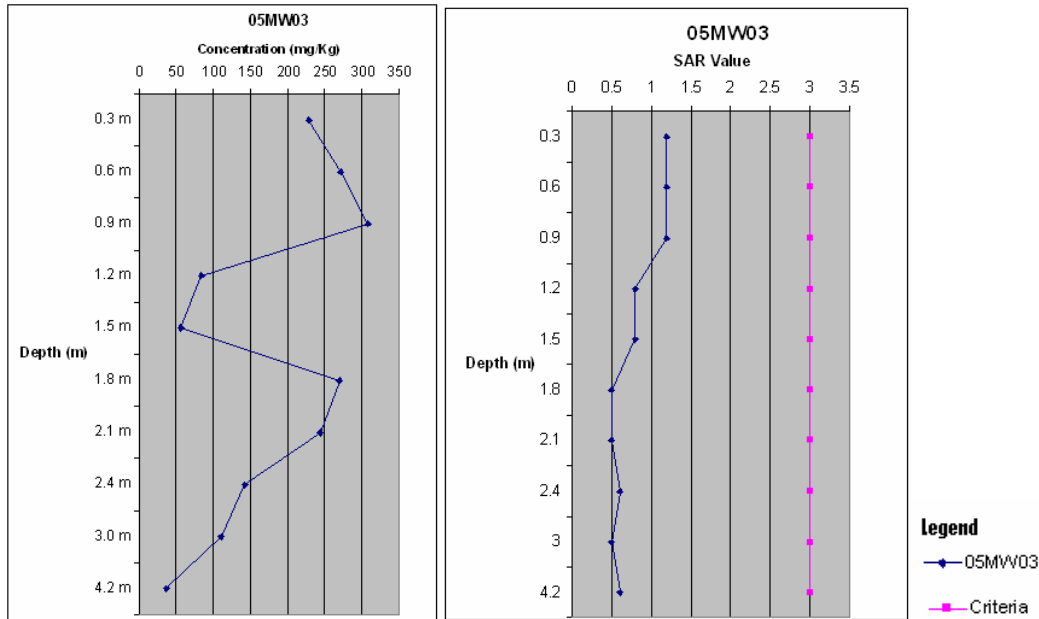
Figure 6A and Figure 6B show the chloride concentrations and SAR values versus depth, respectively, in the vicinity of the pipeline break area (05MW03). The chloride concentrations to a depth of 1.8 m ranged between 309.39 mg/kg (0.9 m) and 55.65 (1.5 m) mg/kg. Beneath the depth of 1.8 m, chloride concentrations decreased from 270 mg/kg (1.8 m) to 36 mg/kg (4.2 m).

No SAR exceedances were detected in this area.

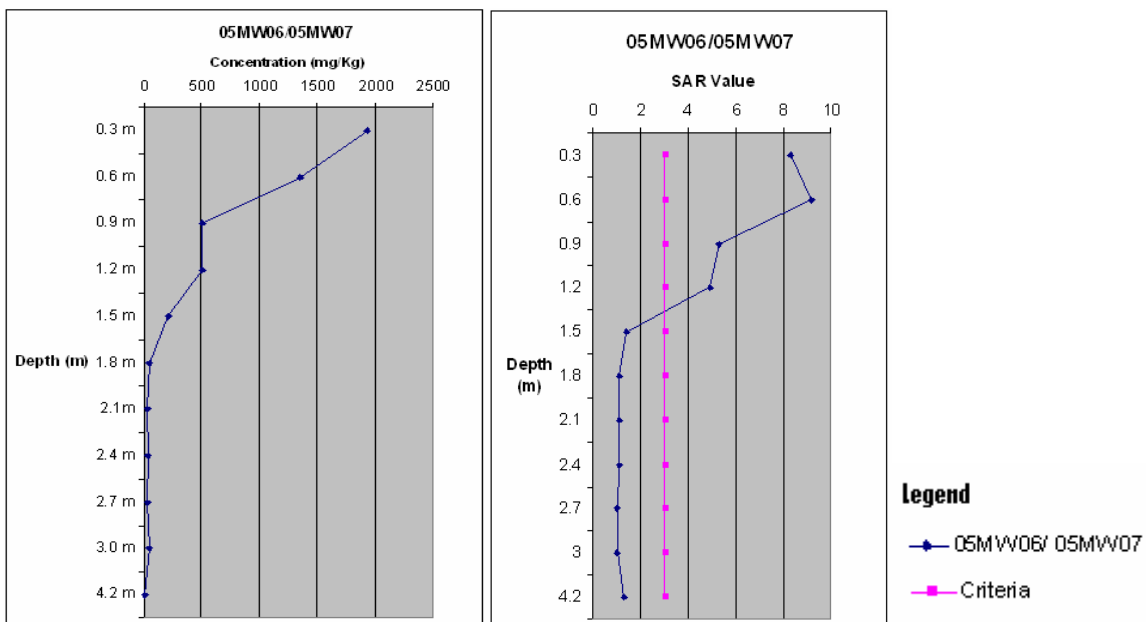
Figure 7A and Figure 7B show the chloride concentrations and SAR values versus depth, respectively in the northeast of the pipeline break area (05MW06/05MW07 nested wells within red purple area shown in 2004 EM 38 map)

The chloride concentrations decreased from 1,936.55 mg/kg at 0.6 m to 51.28 mg/kg at 1.8 m depth. The soil samples collected between 2.1 m to 4.2 m depth exhibited the chloride concentrations ranging between 33.15 mg/kg and 9.45 mg/kg. The SAR values exceeded the criteria at the depth of 0.3 m, 0.6 m, 0.9 m, and 1.2 m and decreased with the depth. SAR exceedances ranged between 4.9 SAR to 9.2 SAR.

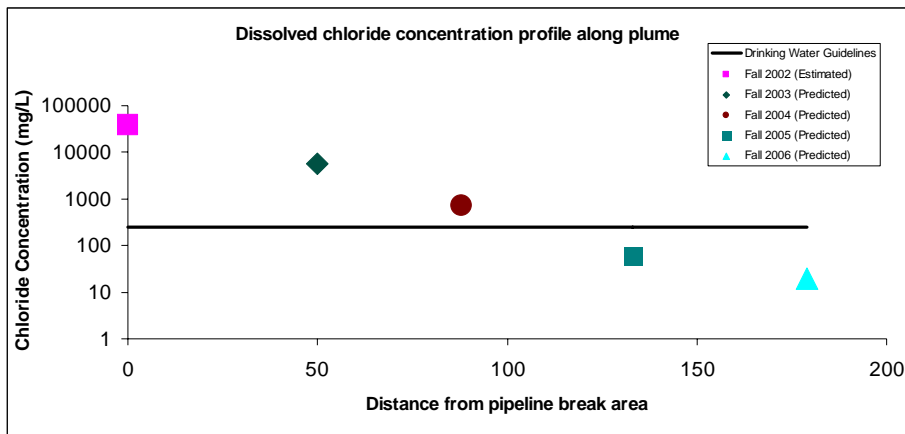
Figure 13: Model calculation results

Figure 13 shows the estimated spatial chloride concentrations at different time steps. The results suggest that initial chloride concentration of 39,100 mg/L in 2002 is decreased to the concentrations ranging between 622 mg/L and 936 mg/L at the end of second time step (two years after the spill). The travel distance in two years is approximately 90 m. This concentration corresponds to the measured concentration of 745 mg/L at the monitoring well 05MW06 drilled at approximately 90 m from the pipeline spill in spring 2005. This was a good calibration for the model and validated the estimated dilution rates due to infiltration, horizontal and vertical groundwater flows. The model was also solved for the future time steps and it was observed that chloride concentrations will decrease to less than the governing drinking water criteria with a travel distance of further 45 m in the next time step (Figure 13).
