THE CITY OF
CALGARY
ENVIRONMENTAL MANAGEMENT

DE-ICER (NaCl) SALT IMPACTED SOIL: 22X REMEDIATION FEASIBILITY STUDY

22X Road Maintenance Yard & Salt Storage Site, Calgary, Alberta

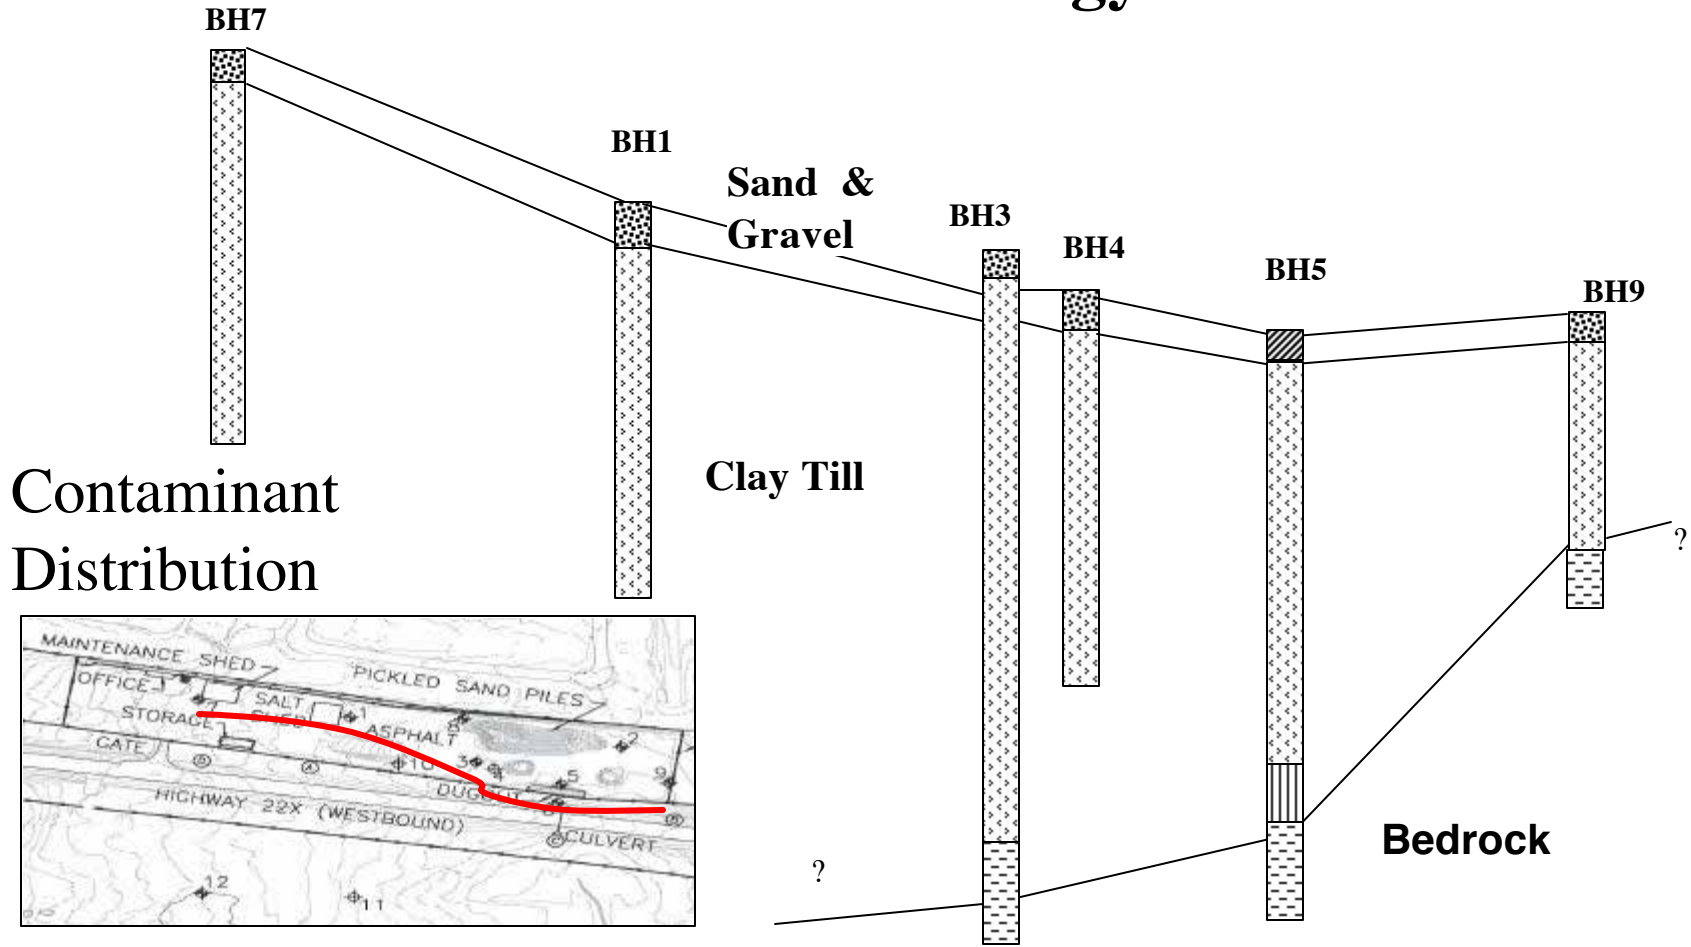
Site Geology

- Geology - Clay Till Overlain by Sand and Gravel
- Hydrogeology - Not Straight Forward
- Clay Till - Grain Sieve Analysis and soil engineering tests
- Site Hydraulic Conductivity - Very Low soil permeability, K from 10^{-8} m/s to 10^{-10} m/s
- Salt Impact Greatest < 1.5 m. On site handling and associated site run-off
- Groundwater Impacts over half the site. Mean concentration of GW composites Na=2090 mg/L and Cl= 4730 mg/L

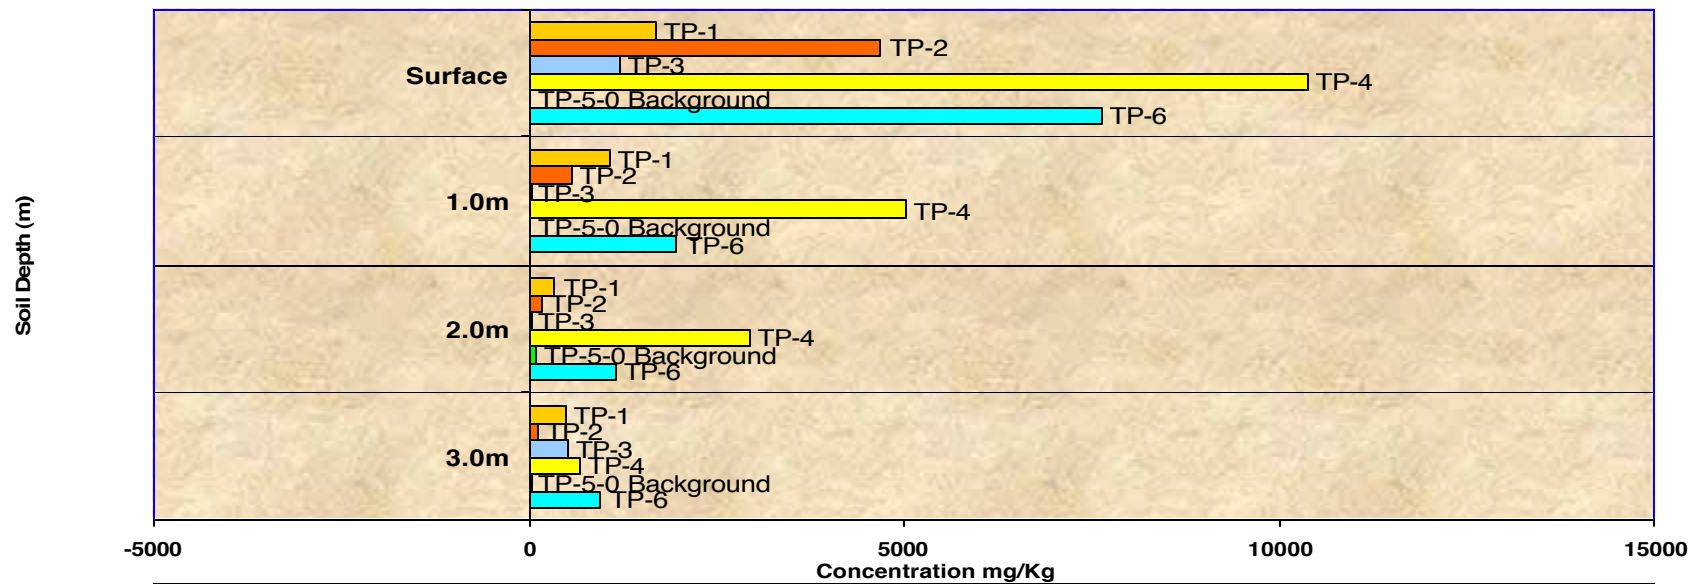
Pre-Remediation Sodium Concentration

**Sodium Concentration in Six Test Pits at Various Soil Depths
22X Road Maintenance Yard and Salt Storage Site, Calgary, Alberta**

3.0m	2.0m	1.0m	Surface
■ TP-1	488	356	1065	1702
■ TP-2	136	178	573	4704
■ TP-3	526	50	44	1225
■ TP-4	695	2947	5038	10373
■ TP-5-0 Background	45	85	23	15
■ TP-6	954	1168	1976	7621

In soils at 1.0m, 2.0m and 3.0 dbgs salt concentrations ranged from 5038 mg/Kg to 50 mg/Kg for sodium and 8556 mg/Kg to 227 mg/Kg for chloride

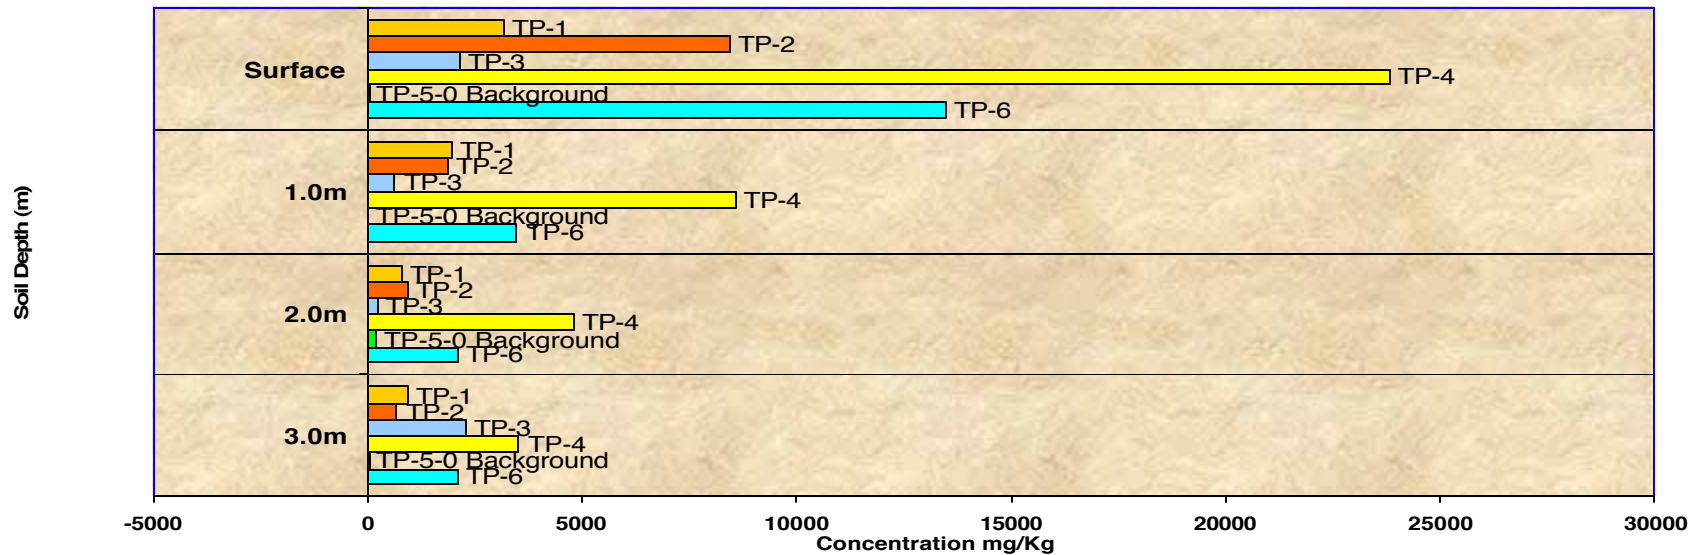
Pre-Remediation Chloride Concentration

**Chloride Concentration in Six Test Pits at Various Soil Depths
22X Road Maintenance Yard and Salt Storage Site, Calgary, Alberta**

3.0m	2.0m	1.0m	Surface
■ TP-1	937	789	1984	3197
■ TP-2	693	916	1871	8433
■ TP-3	2306	227	646	2133
■ TP-4	3545	4818	8556	23801
■ TP-5-0 Background	69	220	21	32
■ TP-6	2119	2110	3468	13502

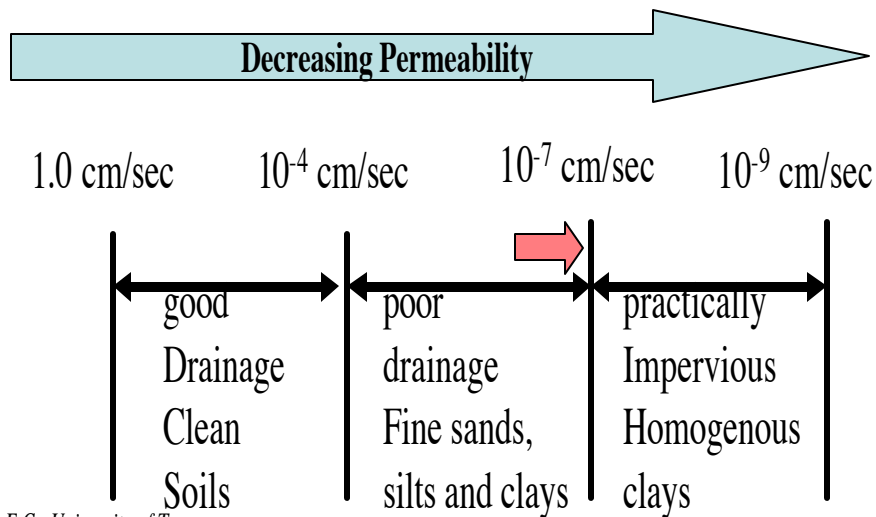
Bench Scale Hydraulic Conductivity

Permeability Measurements

Casagrande Benchmark Values³

- a) Low Permeability K ($< 1 \times 10^{-6}$ cm/s)
- b) High De-icer Salt (Na^+ and Cl^-) Contamination
- c) High EC and SAR that exceed Alberta Environment Guidelines

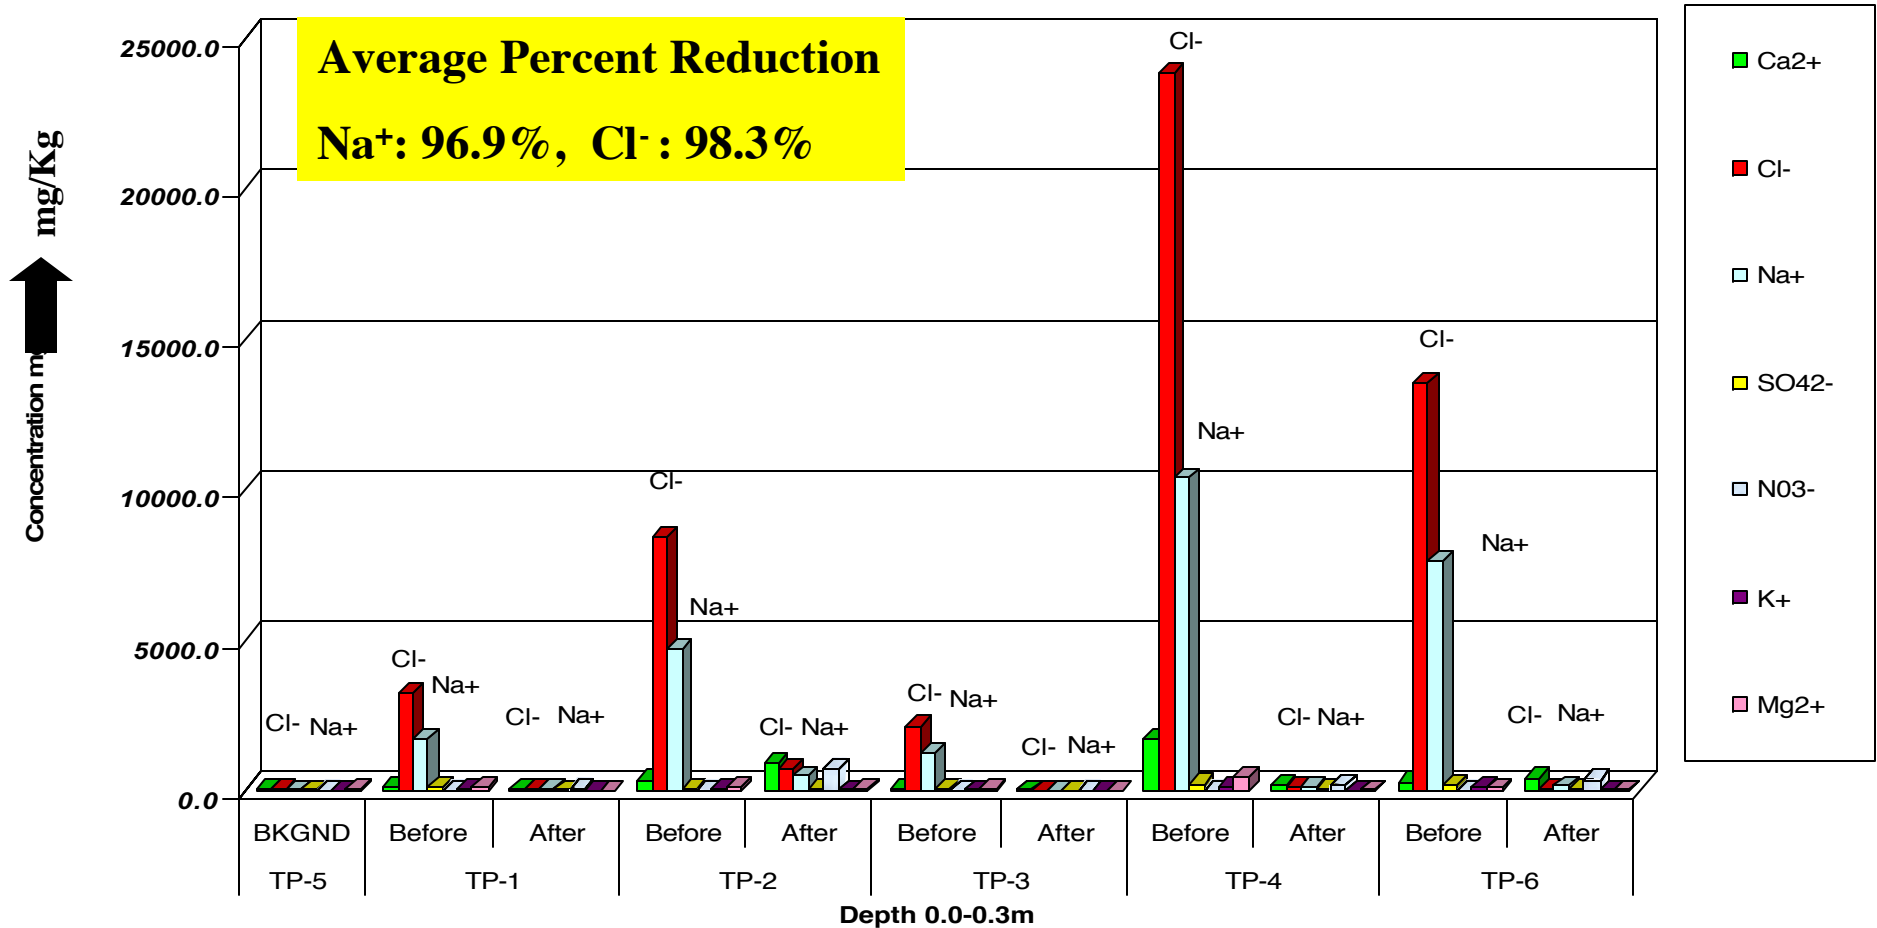
1) Post Remediation SFR Results

22-X HIGHWAYS MAINTENANCE YARD AND SALT STORAGE SITE, CALGARY, ALBERTA

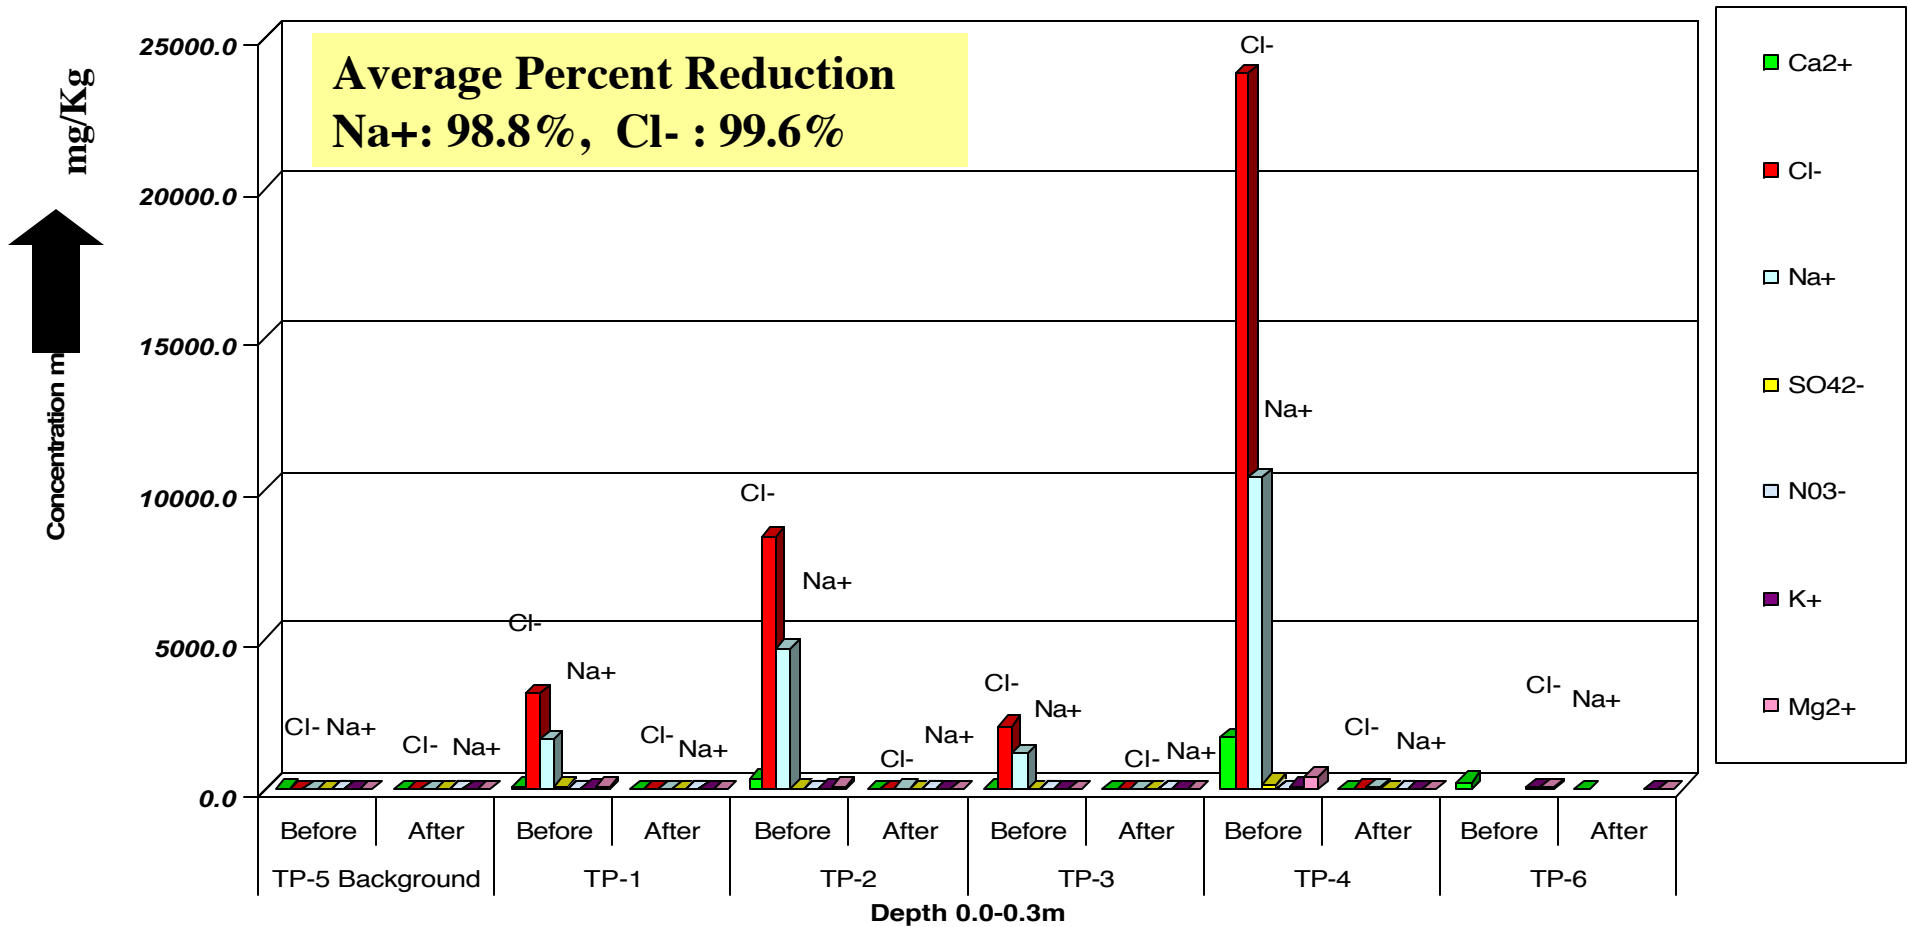
2) Post Remediation SCA Results

22-X HIGHWAYS MAINTENANCE YARD AND SALT STORAGE SITE, CALGARY, ALBERTA

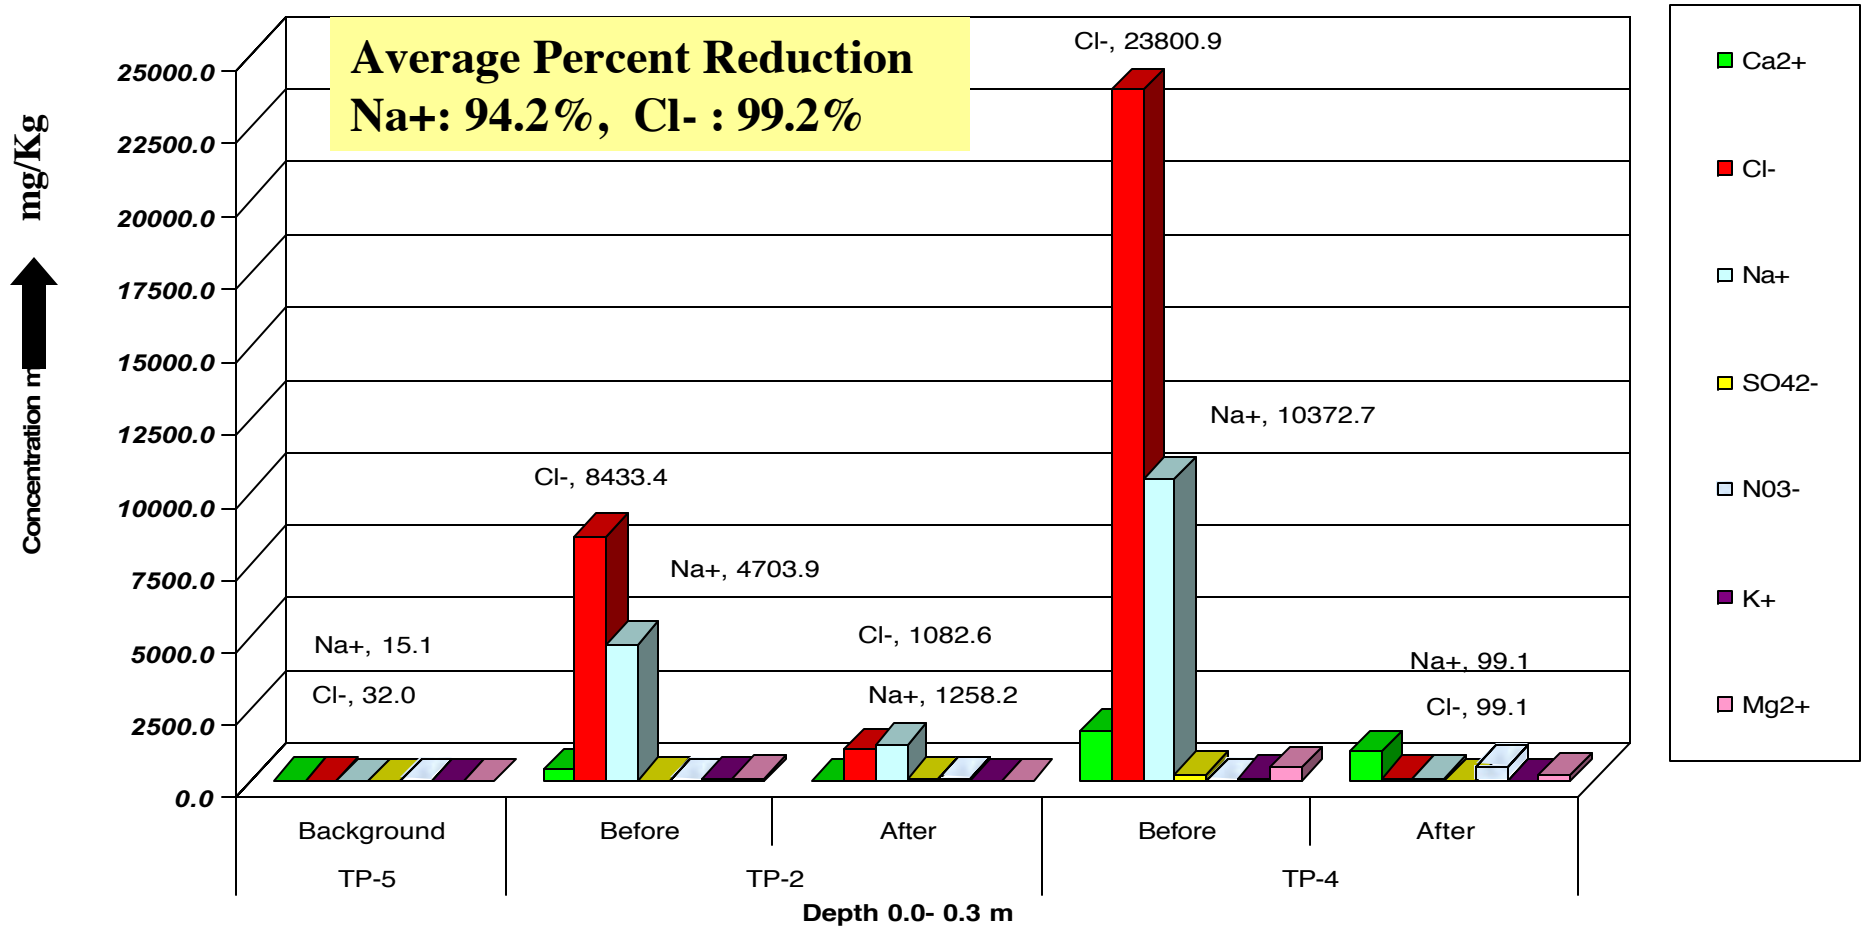
3) Post Remediation EKR Results

22-X HIGHWAYS MAINTENANCE YARD AND SALT STORAGE SITE, CALGARY, ALBERTA, CANADA

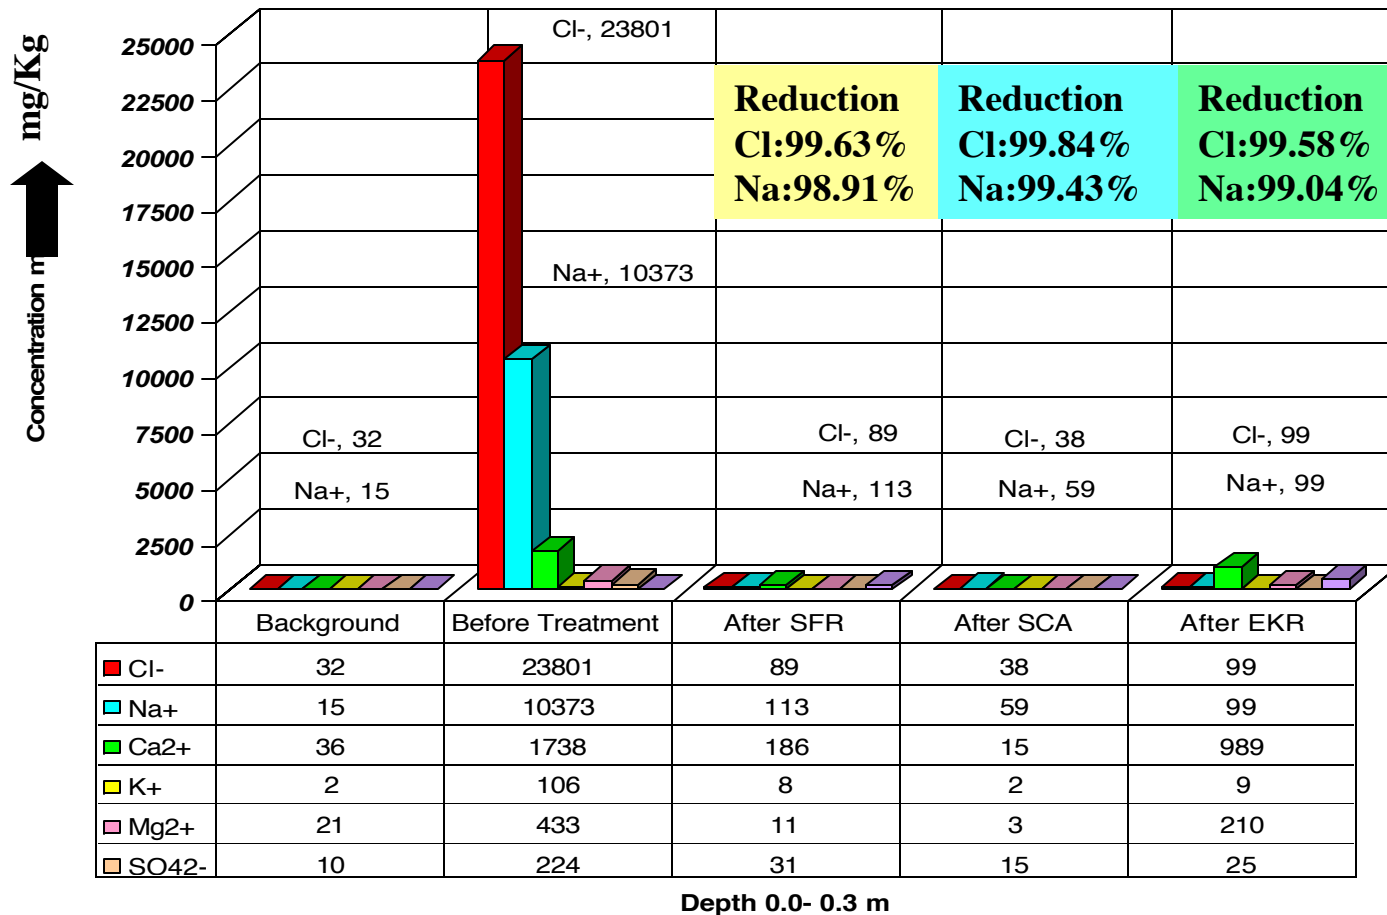
4) Comparison of Three Soil NaCl Results

**REDUCTION OF DE-ICER NaCl IN SURFACE SOILS, AFTER SFR, SCA & EKR TREATMENT
22-X ROAD MAINTENANCE YARD AND SALT STORAGE SITE, CALGARY, ALBERTA**

- *All three Remedial Technologies evaluated reduced Na Cl from soils > 98.0%;*
- *SFR and EKR met guidelines for SAR <12. SCA exceeded SAR Guidelines.*
- *SCA met EC <4 dS/m. SFR & EKR exceeded EC Guidelines.*

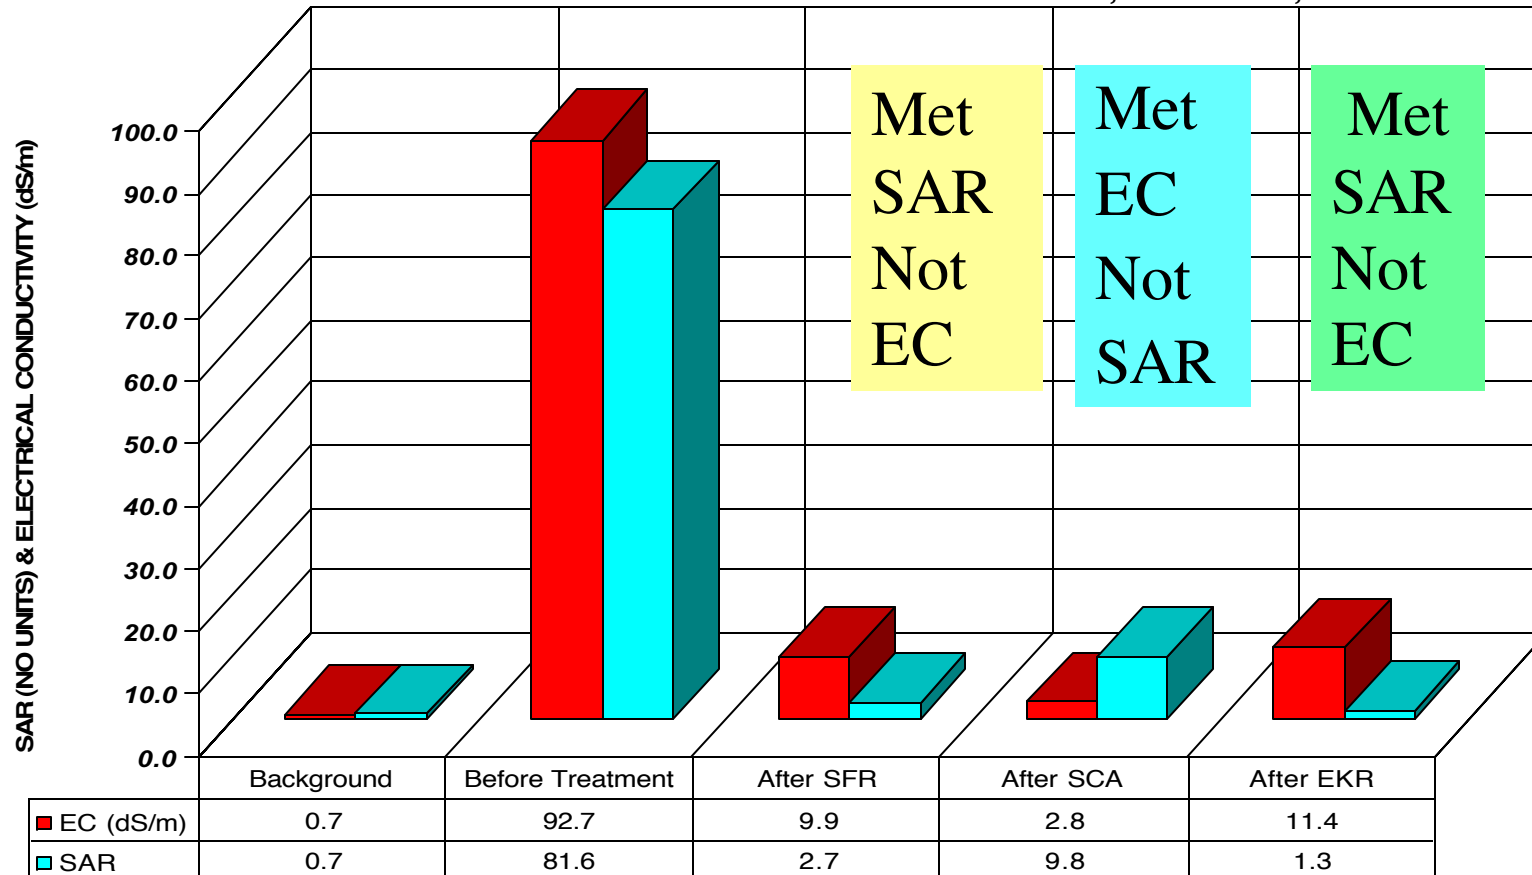
5) Comparison of Three Soil Quality Results

**REDUCTION OF SODIUM ABSORPTION RATIO AND ELECTRICAL CONDUCTIVITY IN SURFACE SOILS, AFTER SFR, SCA & EKR TREATMENTS
22-X ROAD MAINTENANCE YARD AND SALT STORAGE SITE, CALGARY, ALBERTA**

Depth 0.0- 0.3 m

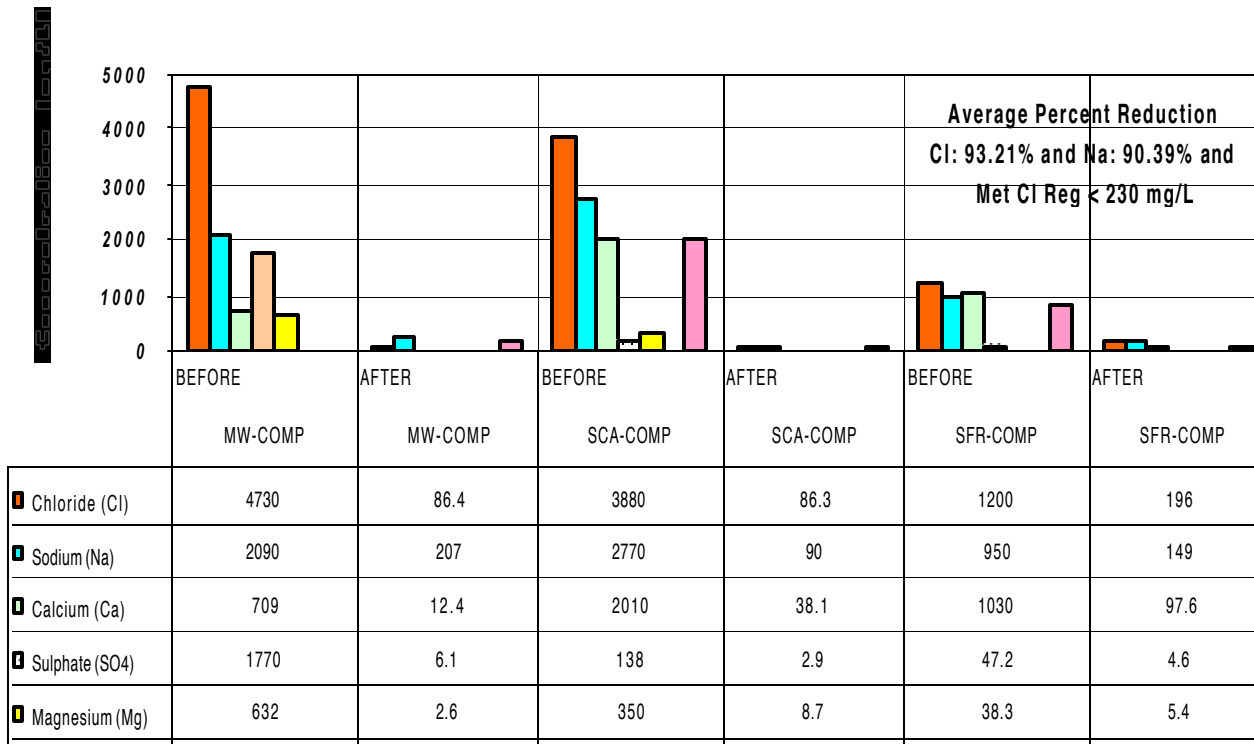
6) Desalination: Water Quality Results

DESALINATION OF MONITORING WELL COMPOSITES, CHEMICAL AMENDMENT LEACHATES AND SOIL
FLUSHED EXTRACTS.
22-X ROAD MAINTENANCE YARD & SALT STORAGE SITE, CALGARY, ALBERTA

Water Composites

- Surface Water quality parameters Cl⁻, Alkalinity as CaCO₃ and pH were under the applicable Alberta Environment Surface Water Quality Guidelines for aquatic life.
- Na⁺ and Cl⁻ in leachate water were reduced by >90.0%

Average Percent Reduction
Cl: 93.21% and Na: 90.39% and
Met Cl Reg < 230 mg/L

- *Desalination permeate < 230 mg/L Cl, Alk as in CaCO₃ <20 mg/L and pH between (6.5-9.0). Met CCME 1999; Surface Water Quality Guidelines and Storm Sewer Discharge-26M98; Sanitary Sewer Discharge- 24M96*

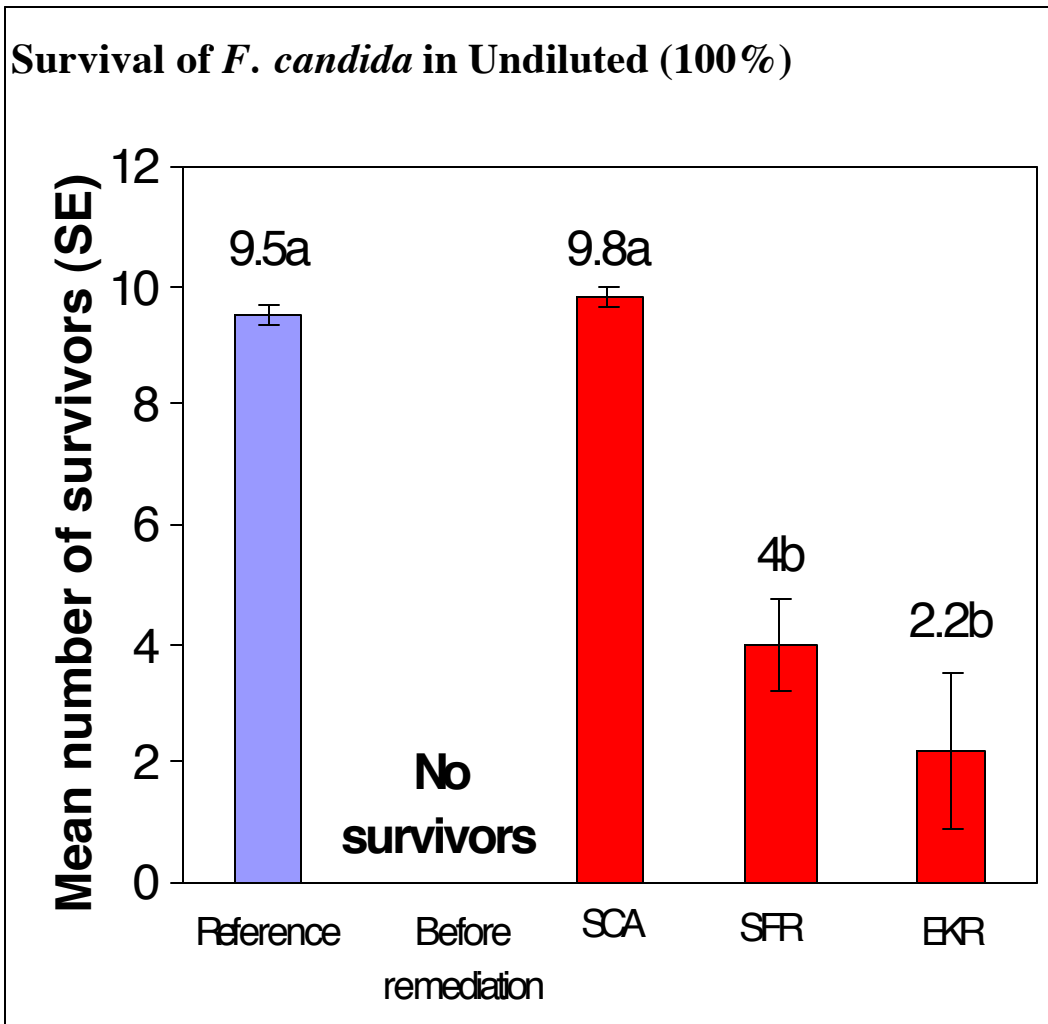
7) Summary of Toxicity Results

- No survival in the contaminated soil before remediation
- Very high survival in both the reference soil and in the SCA soils. **SCA Soil Non-toxic**
- Significantly lower survival in soils treated by SFR or EKR
- A 20% reference soil and up to 80% remediated soil mixture of either SFR or EKR soil was Non-Toxic
- Soil structure appeared to be impacted by the SCA treatment, and formed hard chunks on drying, a factor that may be important under field conditions.

- *Toxicological tests (SCA soil non-toxic), plant bio-assay (SFR soil not phyto-toxic) and leachate control (>98% for NaCl)*

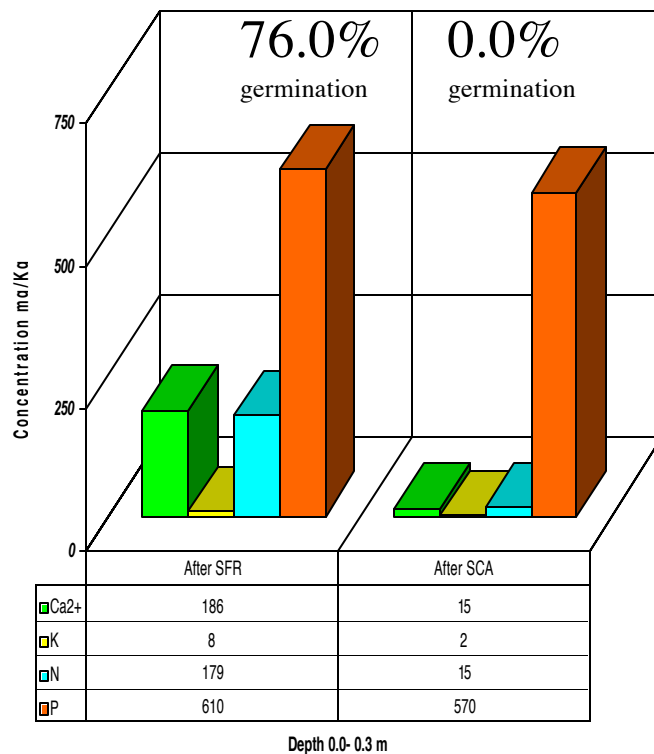
8) Summary of Phytotoxicity & Leachate Results

NUTRIENT IN SURFACE SOILS FOR VEGETATION, AFTER SFR & SCA TREATMENT
22-X ROAD MAINTENANCE YARD AND SALT STORAGE SITE, CALGARY, ALBERTA

- 1) TP-4 **SFR** Germination 76.0%.
No evidence of phyto-toxicity
- 2) TP-4 **SCA**: Germination 0.0%.
Evidence of phyto-toxicity
- 3) TP-4 **50:50 SCA diluted with reference soil**: Germination 44.0%. Evidence of phyto-toxicity. Further investigation?

Na⁺ 98.0%
Cl⁻ 99.3%
